REAL BIG WATER & POWER

Portage Trail Substation
Cuyahoga Falls, OH

Sample ID: PWP-C-03422-5-1-LTC
Equip. Desc.: C-03422-5-1; Load Tap Changer
Lubricant Type: Shell Dalina
Reservoir Cap.: 345.00 Gal(s) 1,305.83 Ltr(s)
Operations: 7,362
Lube Time: Not Provided Hr(s)

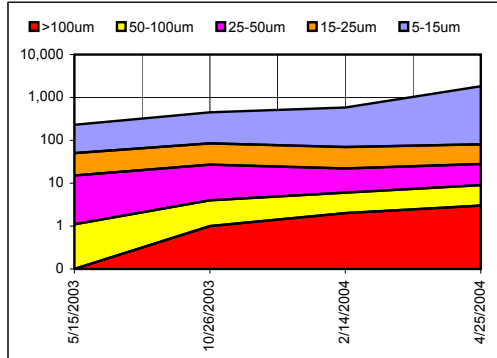
NAS-1638 Particle Count

The equipment particle concentration (EPC) has increased for this equipment from 581 to 1,826, this EPC level remains well within acceptable limits for this type of equipment. Analytical results show a high concentration of Ferrous metal particles. These metal particles are from the Load Tap Changer (LTC) mounting hardware. The movement of this hardware has resulted in the electrical discharge to surrounding components. Indication of the electrical discharge is from the generation of Spheres. The electrical discharge is supported by the increasing concentration of Coking and Filming compounds. Analysis also show particles in the 60 micrometer (um) range along with 120um Cutting wear indicating wear on the switch shaft. The Filming compounds can be quantified in terms of Coking at 78 ppm, Oxidation at 4.37 Abs/cm, Nitration at 1.26 Abs/cm, Sulfur at 5.43 Abs/cm. Volatile and explosive compounds in the form of Alkanes have continue to increase from 3.45 to 7.89 to 9.20 Abs/cm. This elevated levels is of great concern and can lead to ignition by the internal electrical discharge.

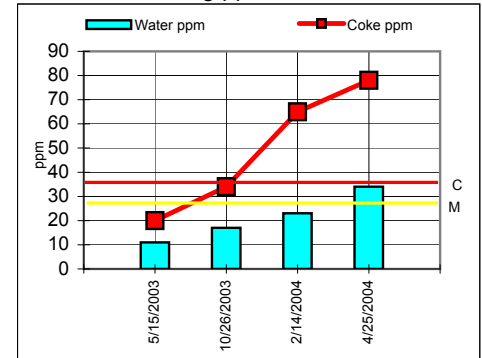
Moisture & Coking ppm

Water contamination is 34 ppm. The combination of Coking and Filming compounds have resulted in the increase of resistive material. These resistive material caused an increase in power levels and burning of fluid as seen in elevated combustible compounds, sulfur and coking. Analysis also shows the presence of Fiber material. This Fiber material is composed of cellulose (paper media) of the insulation and indicates the degradation of this insulation.

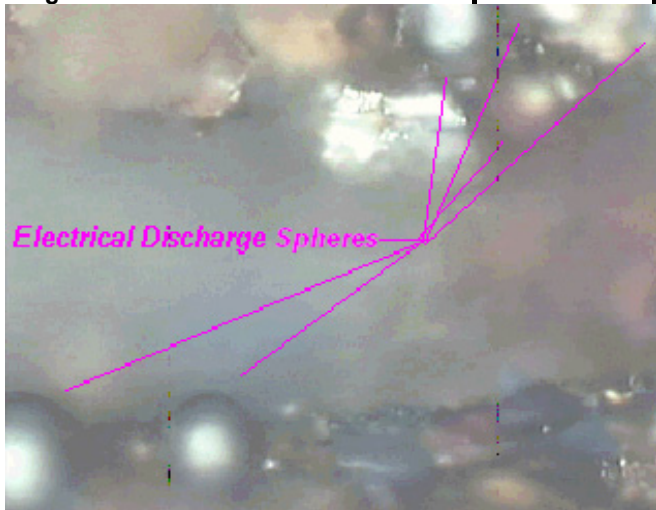
Image 1

Shown in this image shows examples of the Electrical Discharge Spheres.

Consider efforts to schedule this unit for maintenance action in the near future. Specifically, inspect contacts for electrical discharge, secure loose mounting hardware and reduce water contamination. CHANGE OR FILTER FLUID to reduce water and coking contamination. CHECK contact tension to ensure it is within O.E.M. specifications. RESAMPLE equipment to verify the generation of electrical discharge properties.

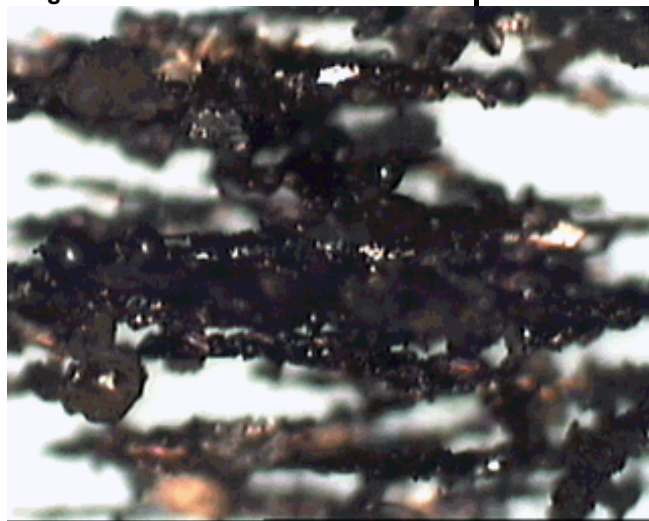
Image 2

This image displays the excessive concentration of Ferrous metal particles Electrical Discharge Spheres. Note that this image was taken under lower magnification to show the extent of the problem.
