REAL BIG WATER & POWER

Portage Trail Substation
Cuyahoga Falls, OH

Sample ID: PWP-C-03422-5-1-LTC
Equip. Desc.: C-03422-5-1; Load Tap Changer
Lubricant Type: Shell Dalina
Reservoir Cap.: 345.00 Gal(s) 1,305.83 Ltr(s)
Operations: 7,362
Lube Time: Not Provided Hr(s)

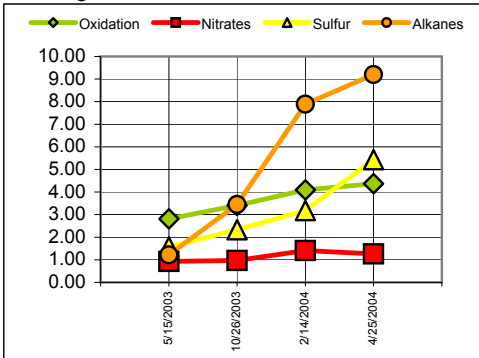
Filming & Volatile Gas Indicators

Water contamination is 34 ppm. The combination of Coking and Filming compounds have resulted in the increase of resistive material. These resistive material caused an increase in power levels and burning of fluid as seen in elevated combustible compounds, sulfur and coking. Analysis also shows the presence of Fiber material. This Fiber material is composed of cellulose (paper media) of the insulation and indicates the degradation of this insulation.

Consider efforts to schedule this unit for maintenance action in the near future. Specifically, inspect contacts for electrical discharge, secure loose mounting hardware and reduce water contamination. CHANGE OR FILTER FLUID to reduce water and coking contamination. CHECK contact tension to ensure it is within O.E.M. specifications. RESAMPLE equipment to verify the generation of electrical discharge properties.
